Improperly Designed Battery Packages Result in Partially Discharged Cells

OddMix.com - Power Technical Note - PWRN0702 - by Karl Nagy

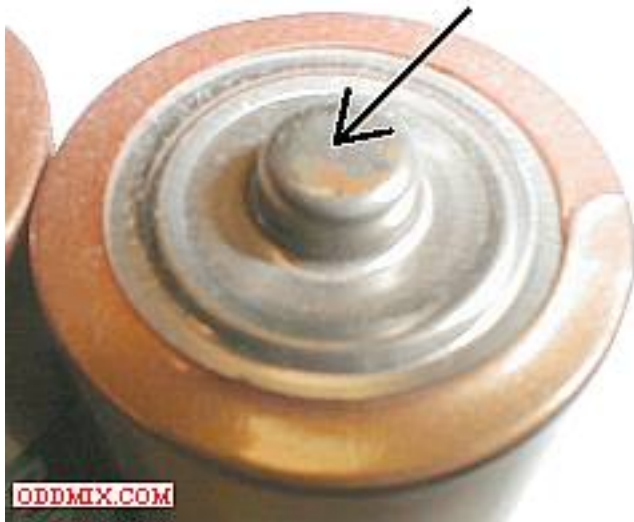
Humid weather can be quite deadly to "dry" cells. That was the conclusion based on the available evidence. Observe the rust on **Picture 1**. in front of the arrow. Recently, a newly opened "fresh" package of batteries, was found weak and uncharacteristically depleted out of the pack. That was puzzling since these batteries have date markings on their sides to indicate their potential shelf life. But those promises of many more years were short lived in this case. To add insult to injury these batteries were not even returnable, because the original package had to be opened to expose this bunch of expensive duds.

Picture 1. Red oxide spots on battery

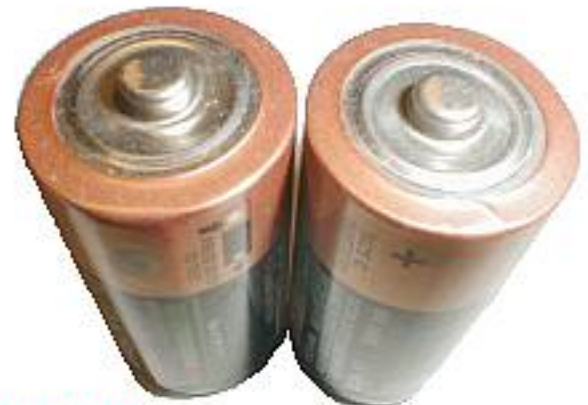
A thorough visual examination of the packaging material provided the evidence to what ailment had sickened these "premium" batteries. The back of the package was cardboard, plain and brown on the inside, richly printed all over on the outside. At first the paper appeared completely above suspicion that it can conduct electricity at all. Rustmarks on the cardboard where the battery plus terminals contact it, and similar rust marks on the positive battery terminals - **Picture 2**. - suggested that not only the paper conducted, but that it did that for a long time. Since the plastic wrapper was intact, it appeared that trapped moisture wetted the paper enough to load the batteries within the enclosed package.

Picture 2. Oxide spots on new batteries

Unfortunately, the plastic wrapper forced the paper to stay in touch with both sides of the battery terminals. Under those conditions, all it required is some time to discharge the batteries. Although clear plastics was used, the conduction marks were completely invisible from the outside, as the battery terminals were blocking the contact points from view.

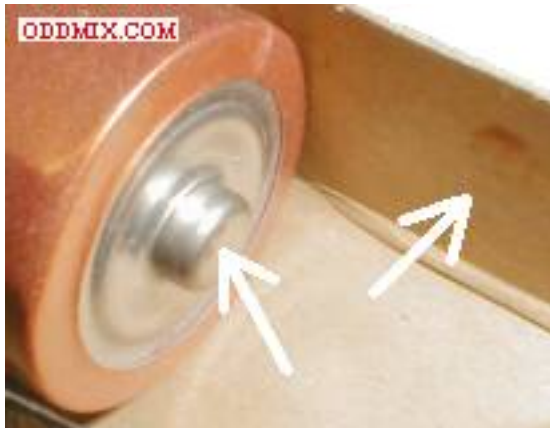
Picture 3. Conduction marks

Pictures 3. and **4.** shows conduction marks on both the packaging materials and on the cell terminals. On cells out of a fresh package there should be absolutely no marks like those whatsoever. If a similarly rusted cell is discovered, and it still have some charge left, clean the terminals from all of the rust before putting them to use. Otherwise the rust will interfere with the flow of the current and the cells would appear worst then they actually are.

Lets assume for a moment that this packaging fiasco was just an honest mistake and not a newly invented marketing tool to increase battery sales. Hopefully many customers noticed that their batteries lasted much less than usual, and complained to the manufacturer vigorously. Perhaps the factory people had seen the light and modified the packages to make them out entirely of nonconductive materials. Even a light oil, or silicone coating would have stoped moisture penetration and could have arrested or greatly reduced unwanted battery discharge.

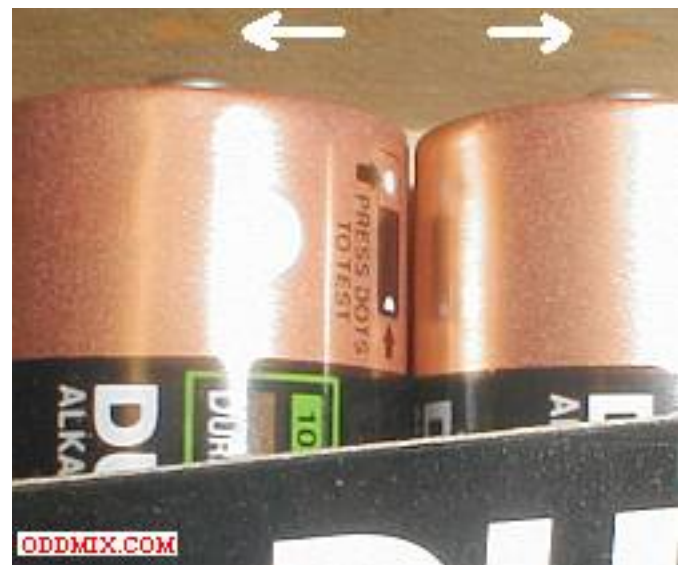
Picture 4. Conduction marks on cardboard

It appears to be wise to stay away from similarly packaged batteries. Smaller cells pack lot less Ampere hours then larger ones. Therefore, they deplete lot faster under similar storage conditions. It is advisable to remove batteries from their packaging materials as soon after purchase as practical. It is a good idea to store them in the refrigerator, but without wrapping because of the moisture condensation that will occur. Always store them with one terminal free and clear of any objects.
